WASTEWATER COLLECTION AND TREATMENT SYSTEM EVALUATION

FOR VEAZIE SEWER DISTRICT

Veazie, Maine

MARCH 2022
JN: 10243.006

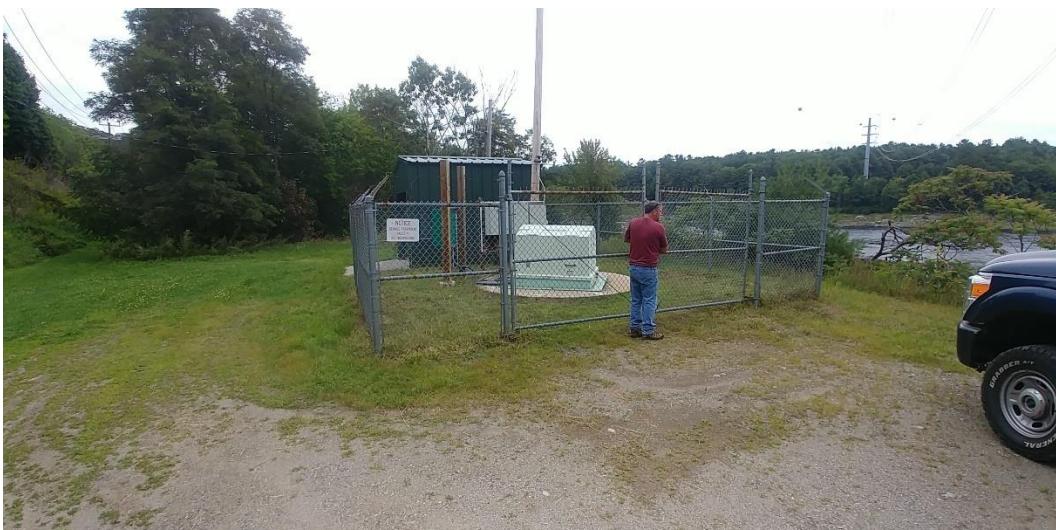
Figure 1: County Road Pump Station

The County Road Pump Station consists of a duplex wet well mounted pump skid, 10-foot diameter precast concrete wet well (18.1 vertical feet), and a portable standby generator in a prefabricated steel building enclosure. The standby generator and enclosure are in good condition, the concrete wet well is in fair condition, and the pump system is in poor condition. There is an approximately 875 linear foot gravel access road to the pump station off Old County Road that appears to be in good condition. There is also a six-foot chain link security fence surrounding the pump station that appears to be in good condition.

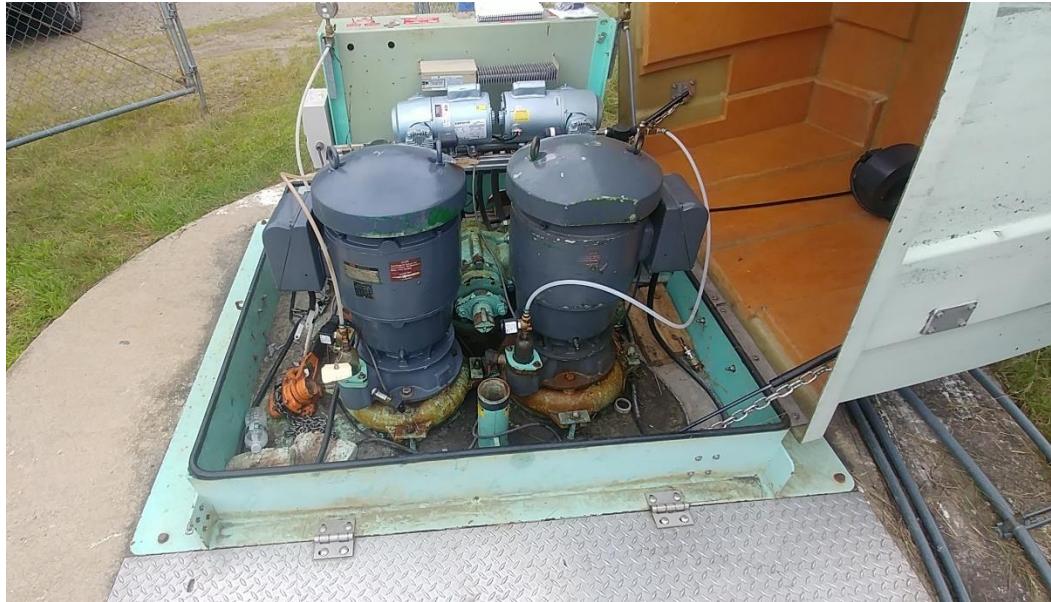
Figure 3: County Road Pump Station Pumps

During the initial inspection, significant vibration was noted in both pumps. Pump 2 had been recently removed and dynamically balanced by a local company but still exhibited considerable vibration. Based on our review of the pump curve and the current operating point, it is likely that the vibration is caused by discharge cavitation. This can occur when the pump is running too far left on the pump curve and the discharge pressure is extremely high. The high discharge pressure causes fluid to circulate inside the pump volute causing cavitation. Signs of discharge cavitation include wear on the tips of the impeller and on the pump volute. See the pump curve in Appendix E.

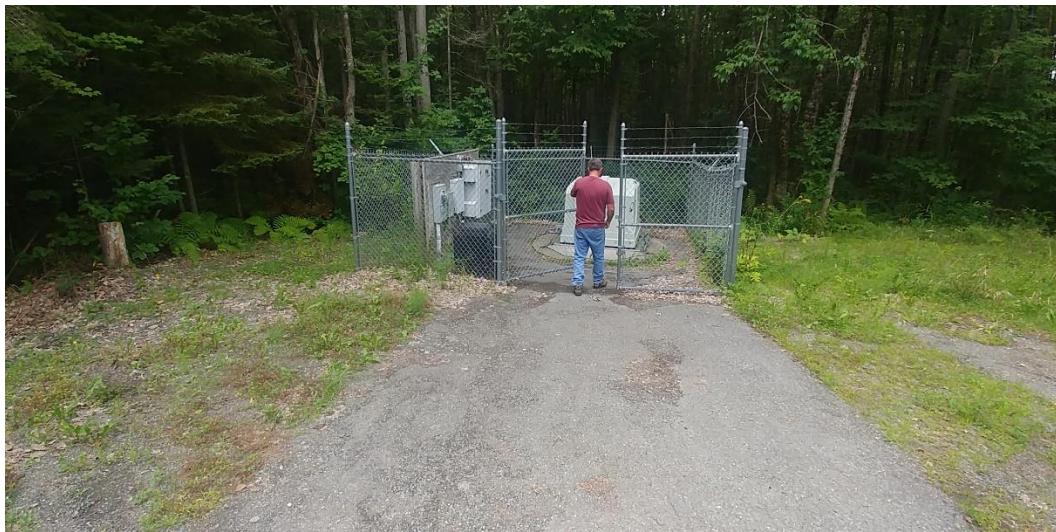
Figure 4: Buck Hill Pump Station

The Buck Hill Pump Station consists of a duplex wet well mounted pump skid on a six-foot diameter precast concrete wet well. There is no standby generator at this location, and it does not appear to have provisions to connect a standby generator. The concrete wet well is in fair condition and the pump system is in poor condition. There is an approximately 300 linear foot gravel access road to the pump station off Buck Hill Drive that appears to be in good condition. There is also a six-foot chain link security fence surrounding the pump station that appears to be in good condition.

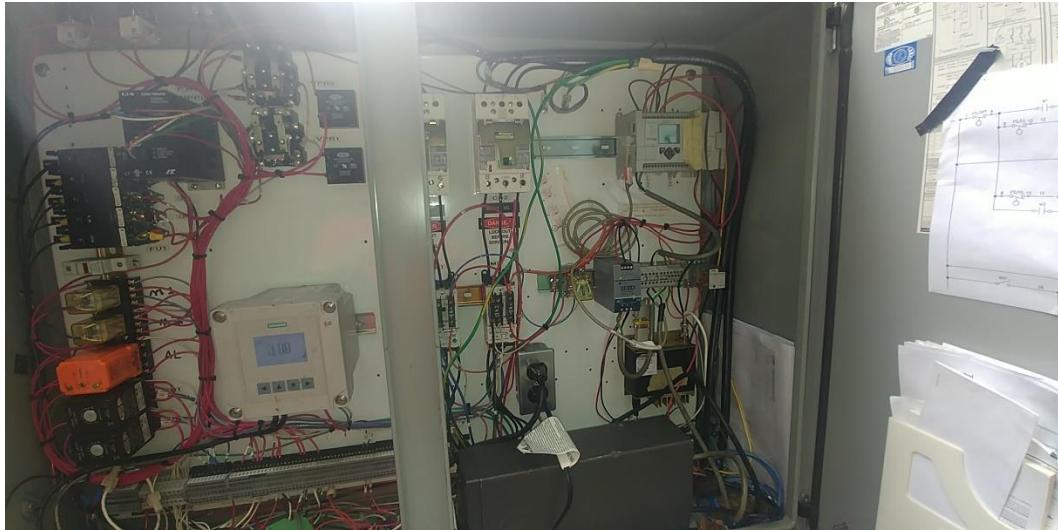
Figure 5: Buck Hill Pump Station Control Panel

S&L indicated that a Protronix II level controller was purchased by the District in 2018. This is a PLC controller with touch screen HMI interface but does not appear to have been installed. The HMI interface at the pump station is not connected. It appears that this pump station has been reconfigured to operate by way of float level control switches with a MicroLogix 1100 programmable logic controller system. This is not the S&L factory control system that was provided with the system. There does appear to be an alternator to switch lead/lag pump operation after each pump cycle. There is also a Siemen ultrasonic sensor to monitor the level in the pump station and report to the SCADA system but is not used for level control. This pump station has radio equipment to transmit level data and alarm conditions to the District's SCADA system. District staff indicated that communication with the pump station had been problematic until recent modifications.

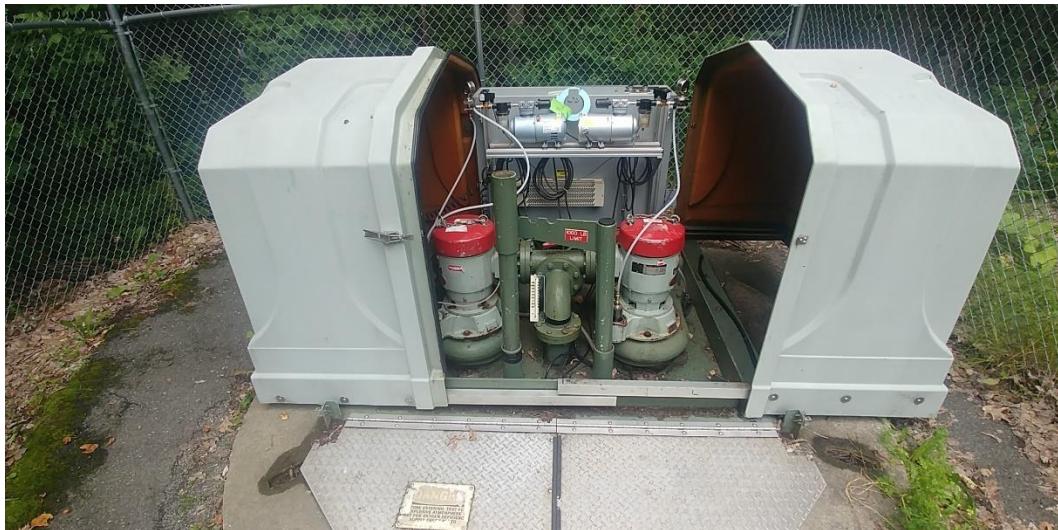
Figure 6: Buck Hill Pump Station Pumps

This S&L pump station has a split case fiberglass enclosure to protect the pumps from the elements and appears to be in fair condition. This enclosure has an electric heater and a ventilation fan. This enclosure is effective at protecting the pumps and allows for access to the pump systems for maintenance. However, like the County Road Pump Station, it is not convenient for maintenance during inclement weather as it exposes both the pump equipment and staff to the weather.

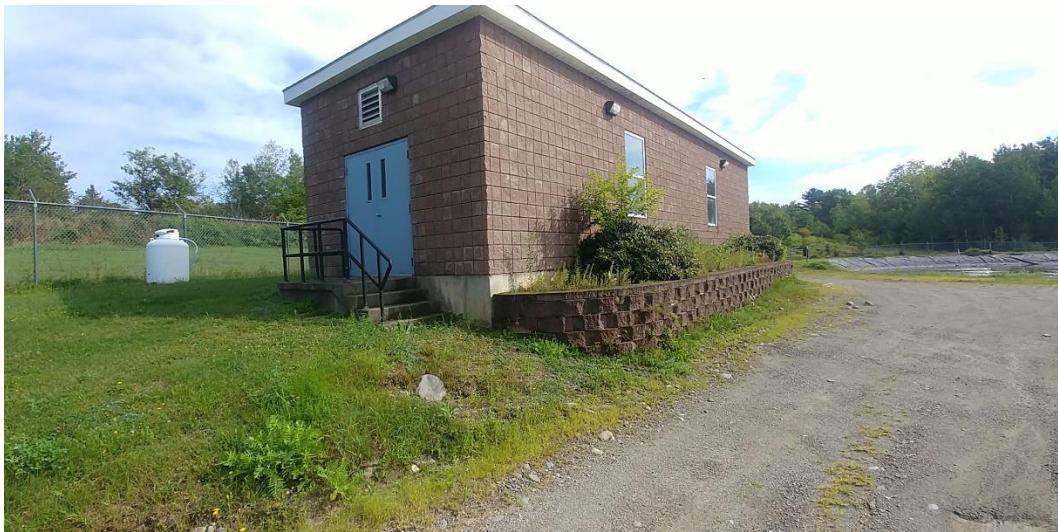
Figure 10: Headworks Building

Overall, the Headworks Building is in fair condition. This building was constructed as part of the 2001 WWTP upgrade. The masonry structure appears to be sound; however, District staff indicated that when the floors are washed in the treatment area, the water seeps between the foundation and concrete block wall. This should be addressed to stop any further degradation of the mortar joint between the foundation and concrete blocks. The interior and exterior joint between the foundation and concrete block wall should be repointed and an epoxy material or concrete curb should be cast over the interior joint for additional protection against wash water.

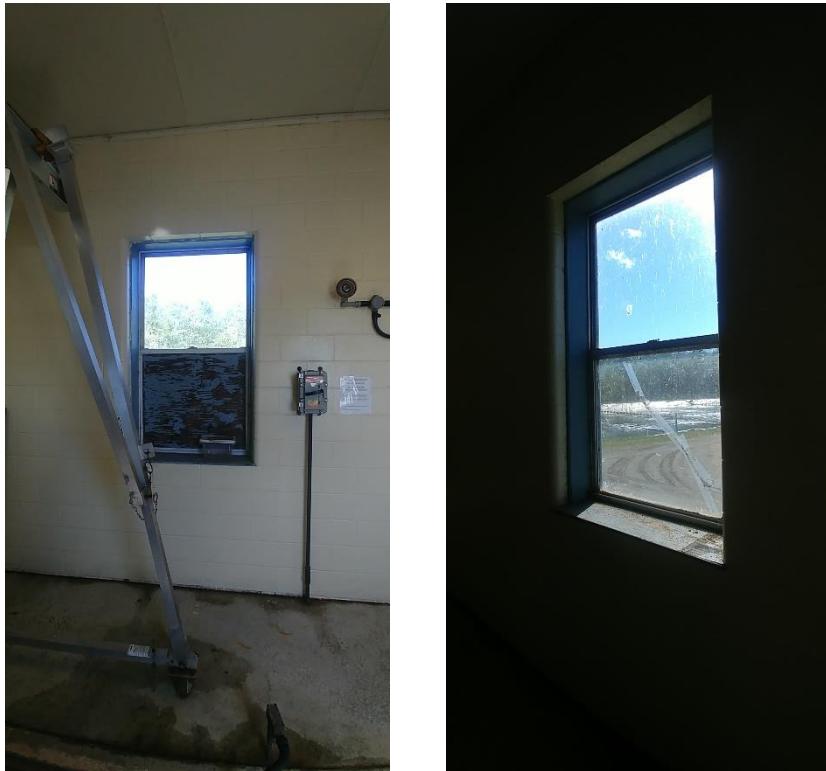
Figure 11 & 12: Headworks Building Damaged Windows

There are three windows in the treatment area of the headworks building, which appear to be original to the 2001 WWTP upgrade. Portion of the window on the northwest end of the building has been broken and repaired with a piece of plywood. The widow on the southwest end of the building is cracked. Both of these windows should be replaced.

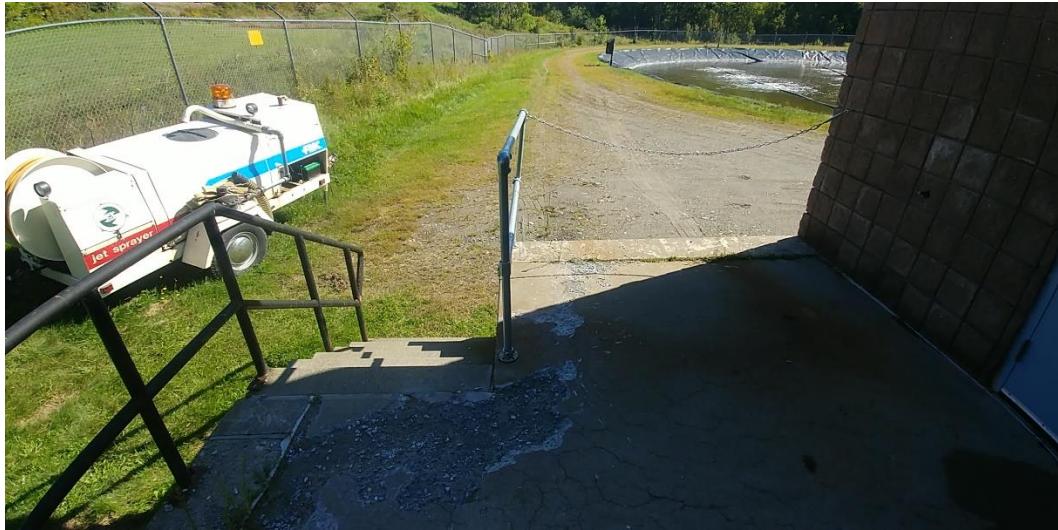
Figure 13: Headworks Building Loading Dock

There are concrete stairs and a loading dock on the northeast corner of the building. The loading dock is used for the disposal of screenings and grit from the headworks. The concrete surface at the top of the stairs and along the loading dock is spalling and should be repaired to prevent further erosion and eliminate a potential tripping hazard. The handrail along the stairs and north side of the loading dock appear to be in good condition and provide adequate protection. The handrail between the stairs and loading dock appear to be in good condition; however, the attachment to the concrete should be addressed. A chain is used across the end of the loading dock, this should be replaced with either a removable handrail or a gate to provide fall protection when the loading dock is not in use.

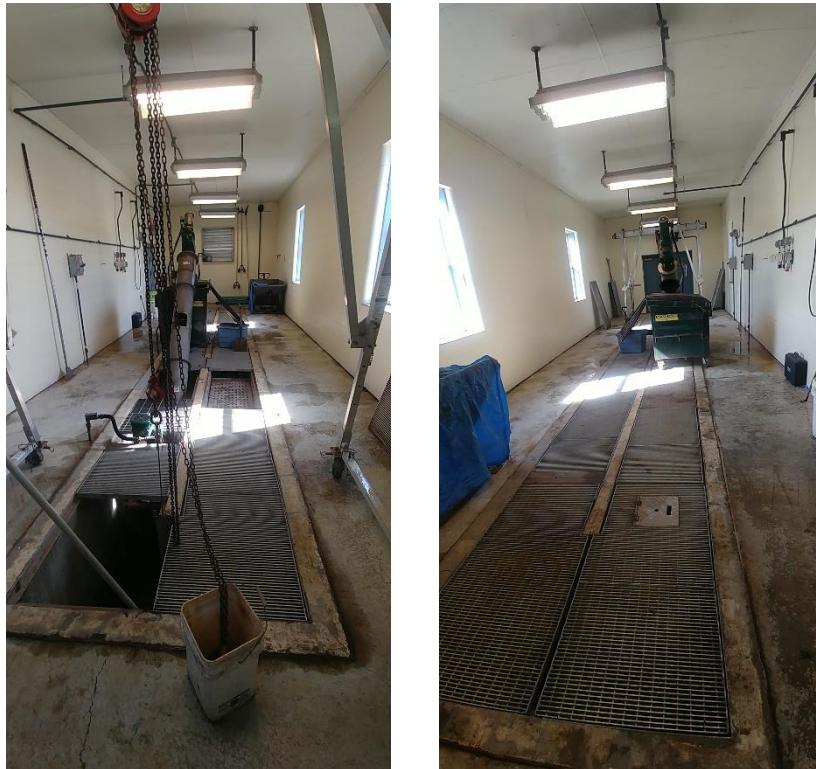
Figure 14 & 15: Headworks Building Influent Channel

The primary and secondary channels in the treatment area are covered with grating. The existing grating appears in fair condition; however, several sections around the equipment have been removed to provide better access to the equipment. These sections of grating should be reinstalled, or removable handrails should be installed in these locations to provide fall protection for District staff.

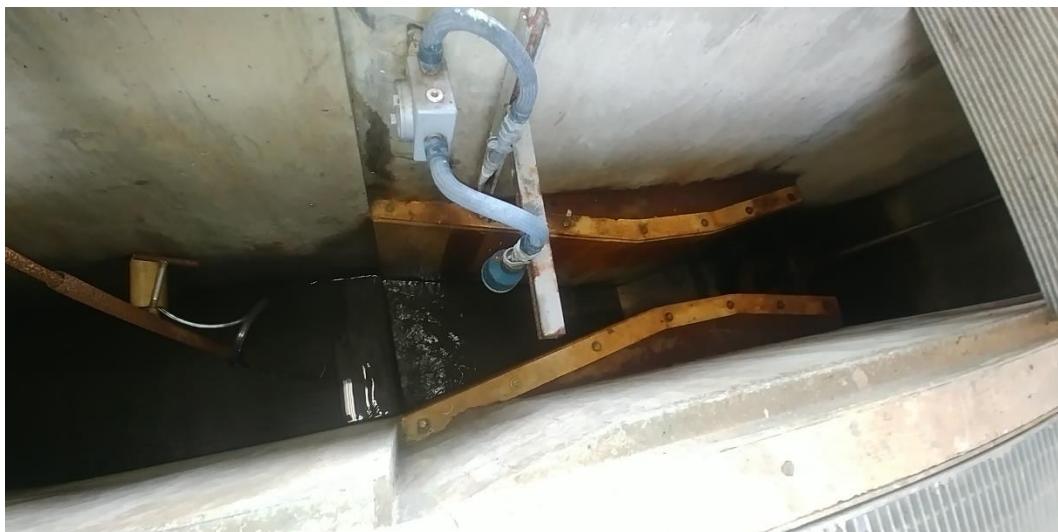
Figure 16: Headworks Building Influent Flowmeter

The influent flowmeter and Parshall flume appear to be in fair condition. The ultrasonic level sensor is suspended over the Parshall flume and provides measurements of the depth of the influent flow which is converted to a flowrate. Level measurement checks should be performed annually to verify the depth of flow provided by the ultrasonic level sensor. The Parshall flume should be checked weekly for any build-up of solids and cleaned as necessary. The ultrasonic level sensor should be cleaned annually and if the flow surcharges and covers the sensor.

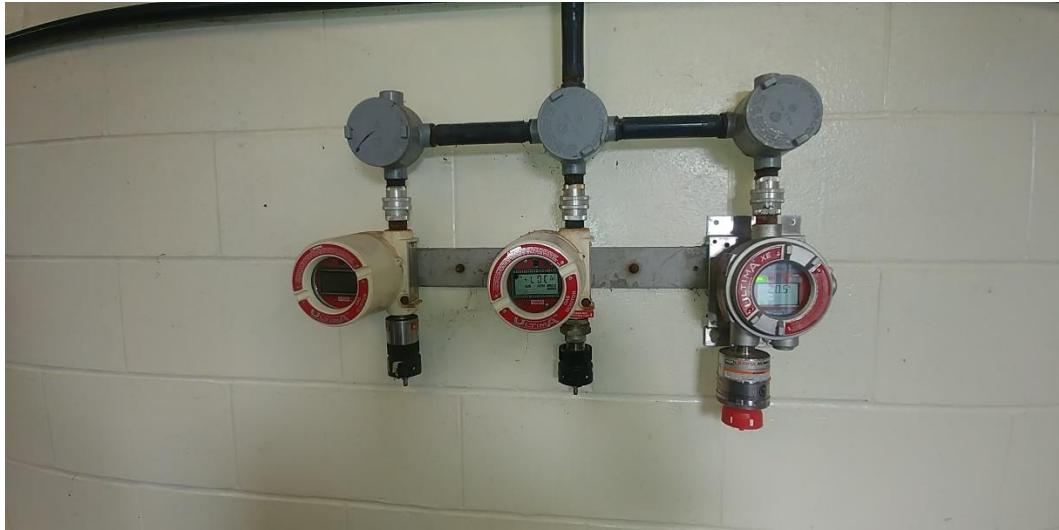
Figure 18: Headworks Building Gas Detection System

The existing gas monitoring equipment (Ultima) in the treatment area of the Headworks Building are used to continuously monitor hazardous locations. There are three gas detection units, Oxygen (O_2), Hydrogen Sulfide (H_2S), and Lower-Explosive-Limit (LEL) and they are mounted to the wall on the northern wall of the treatment area. Each gas detection units are comprised of a monitor unit with digital display and a gas sensor. The Oxygen unit is an Ultima XE unit and appears to be a newer unit and in good condition. The LEL and H_2S gas monitor units appear to be older models and do not appear to be operational. This should be corrected immediately. The Ultima Safety Manual indicate that the units should be calibrated to ensure accuracy and detect any sensor problems. This manual also states that the sensors have a limited lifetime and must be replaced periodically to ensure proper operation. Unless historical calibration records show that sensors consistently last longer Ultima recommends that oxygen (O_2) and toxic sensors (H_2S) should be replaced once per year and that the catalytic combustible sensors (LEL) should be replace every 18 months. The District should follow the manufacturers' recommendations and document when the units are periodically calibrated and when the sensors are replaced.

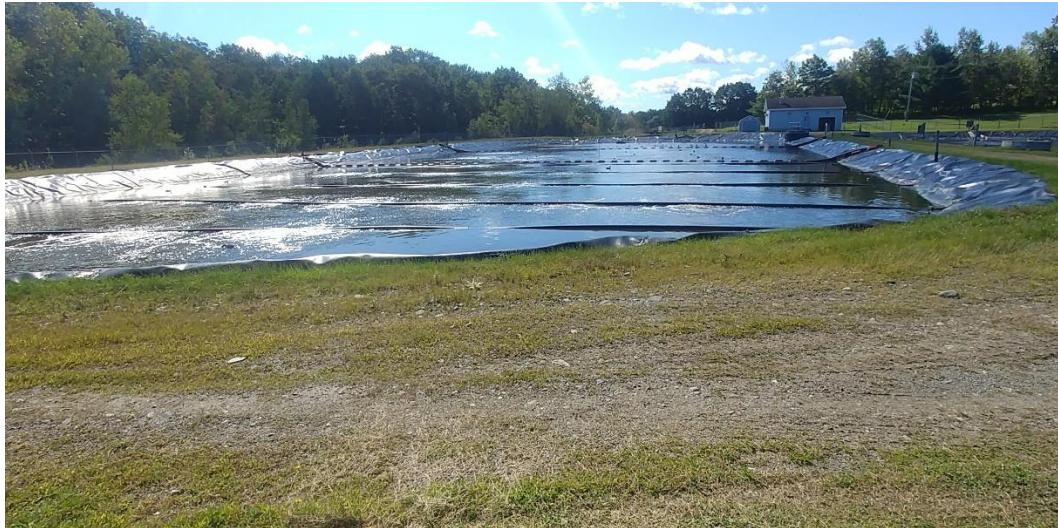
Figure 19: Lagoon #1

Overall Lagoon #1 appears to be in fair condition. The exposed portion of the existing HDPE liner appears in good condition with no observed cracks or breaks in the liner. The liner was installed as part of the 2001 upgrade project and is approximately 20 years old. The life expectancy of a HDPE liner depends on the environment, temperature and chemicals that it is exposed to. The use of UV inhibitors, such as carbon black, can extend the life expectancy of liners that are exposed to sunlight. In an exposed application, the life expectancy of HDPE liners can be 20+ years. The best way to determine if a liner needs to be replaced is to send a sample of the liner to a laboratory for testing. Based on laboratory testing, if the mechanical properties are at half the original values the liner should be replaced.

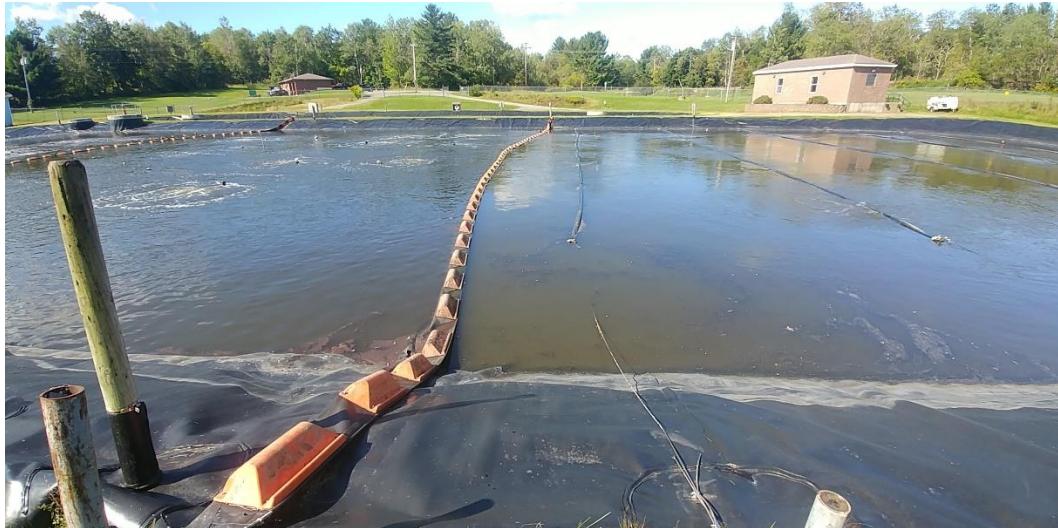
Figure 20: Lagoon #1 Baffle

There are two floating baffle walls in this lagoon that separate the cells and produce a "serpentine" flow pattern and minimize short circuiting of flow through the lagoon. District staff indicated that both of the baffle walls were replaced in 2014. The baffle floats appear to be in good condition with no low spots that could cause short circuiting of flow, however there are several small holes in the baffle near the floats. These holes should be repaired to prevent further enlargement of the holes and potential short circuiting in the lagoon. These baffles typically have a service life of 15-20 years. The District should repair the holes in the baffle and should plan for the replacement of these baffles within the next 7-10 years.

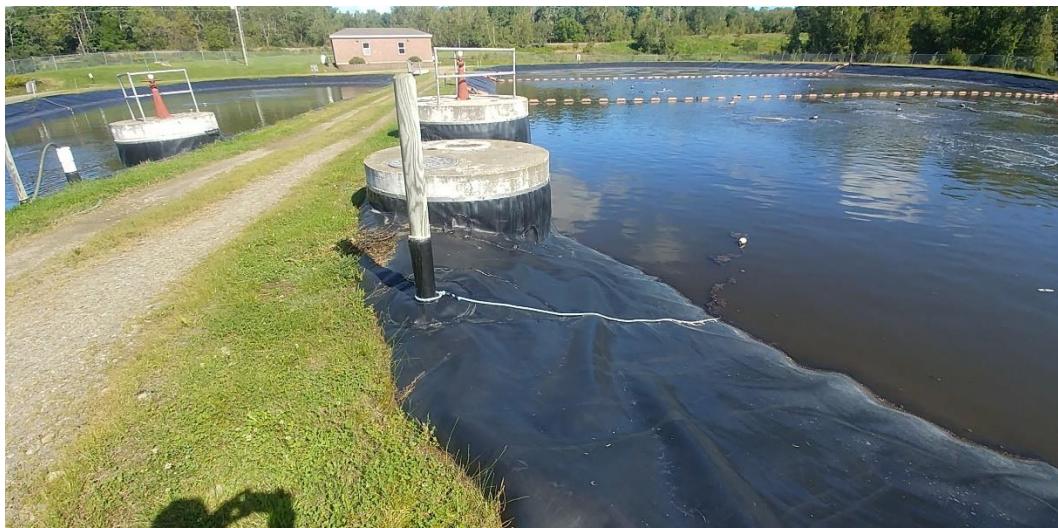
Figure 21: Lagoon #1 TLV Structures

The TLV #1 precast concrete structure, that is located in the southwestern corner of Lagoon #1 appear in fair condition. The level control valve actuator associated with this structure is in fair condition. All level control structures should be cleaned on an annual basis.

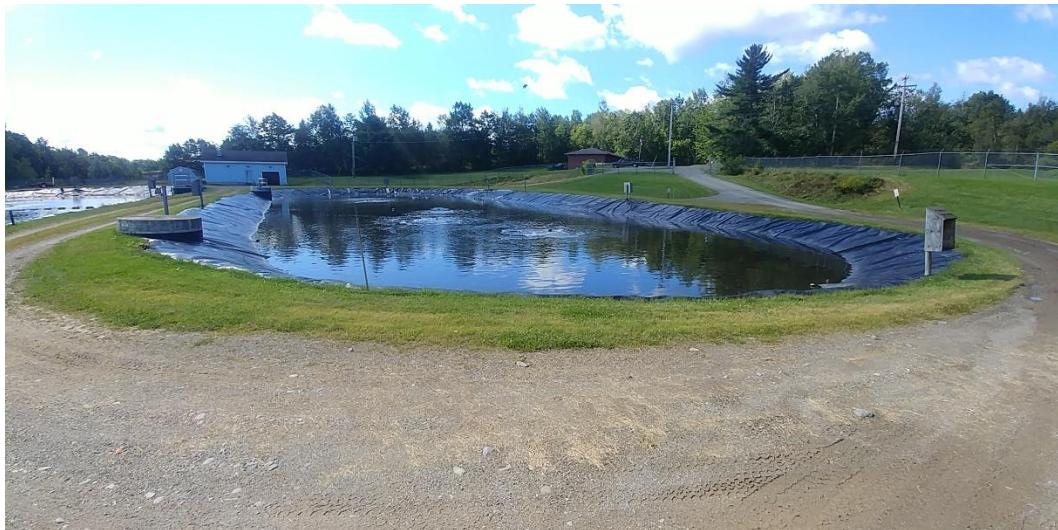
Figure 23: Lagoon #2

Overall Lagoon #2 appears to be in fair condition. The exposed portion of the existing HDPE liner appears in good condition with no observed cracks or breaks in the liner. There is a section of the liner that is floating along the northwestern side of the lagoon. This is an indication of ground water beneath the liner. Similar to Lagoon #1, this liner was installed as part of the 2001 upgrade project and is approximately 20 years old.

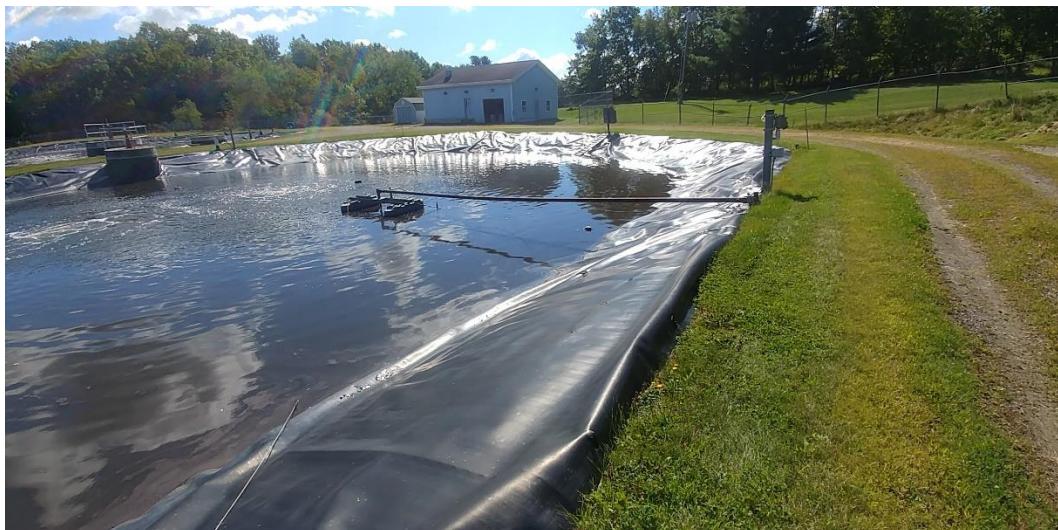
Figure 24: Lagoon #2 Abandoned Equipment

There is a portion of an old floating mechanical surface aerator in the southwestern corner of the lagoon that is no longer in service and should be removed.

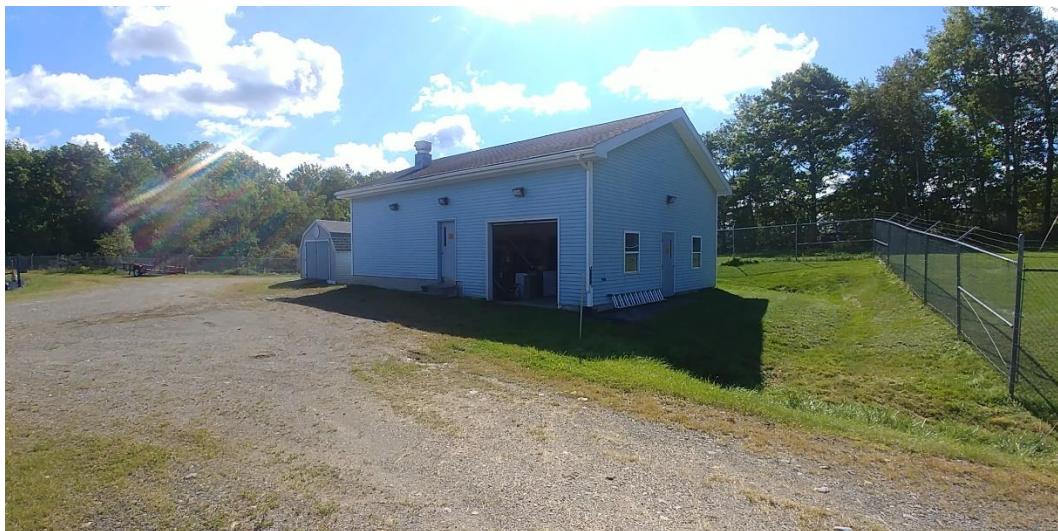
Figure 26: Blower Building

Overall, the Blower Building is in poor condition. The wood frame structure appears to be in fair condition; however, the roofing and siding appear to be in poor condition. The roof is leaking in the blower room. The vinyl siding appears to be original from the 2001 upgrade and appears to be in poor condition. There are several broken pieces of siding and corner pieces that should be replaced.

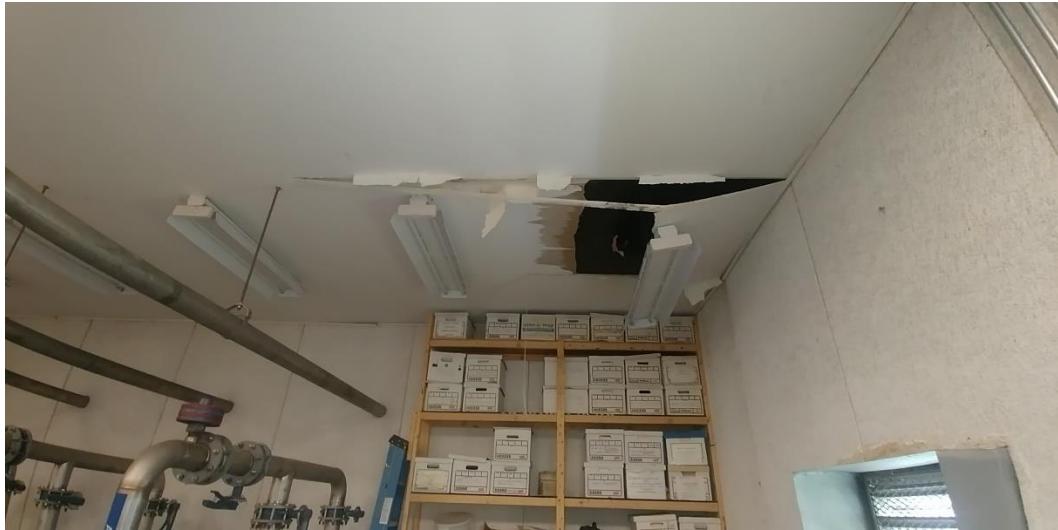
Figure 27: Blower Building Damaged Ceiling

The roofing appears to be in very poor condition as there is a leak in the roof above the blower area that has caused a section of the gypsum ceiling in this area to fall in. It is unknown what other water damage has been caused in the attic area of this building. The asphalt roof shingles appear to be in very poor condition. The singles appear to be original to the 2001 WWTP upgrade and are approximately 20 years old. Typical asphalt shingles have a service life of 20-30 years. The District should plan to replace the roofing and shingles immediately. Further investigation would be necessary to determine if/how much of the ceiling insulation would need to be replaced.

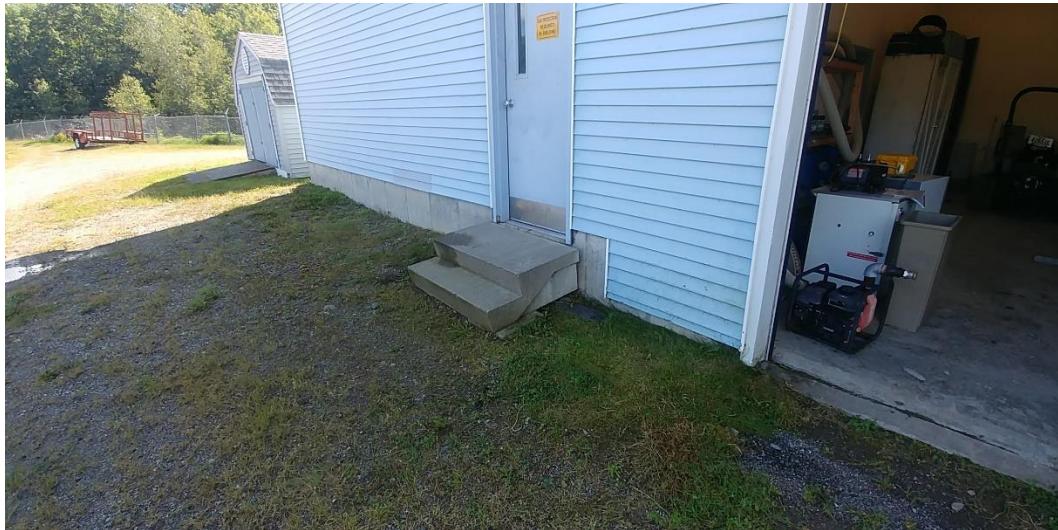
Figure 28: Blower Building Access Stairs

There are two three-foot steel exterior doors that provide access to the garage area and blower room, which appear to be in fair conditions. The floors for the garage area and blower room are at two different levels. The garage floor is at grade with the exterior surface and the blower room is 18 inches higher. The entry door for the blower room has precast concrete steps. There are only two steps and therefore hand railing is not required. The steps should be leveled. There is a three-foot steel interior door that provides access between the garage area and the blower room. There is a nine-foot garage door in the garage area and appears in good condition.

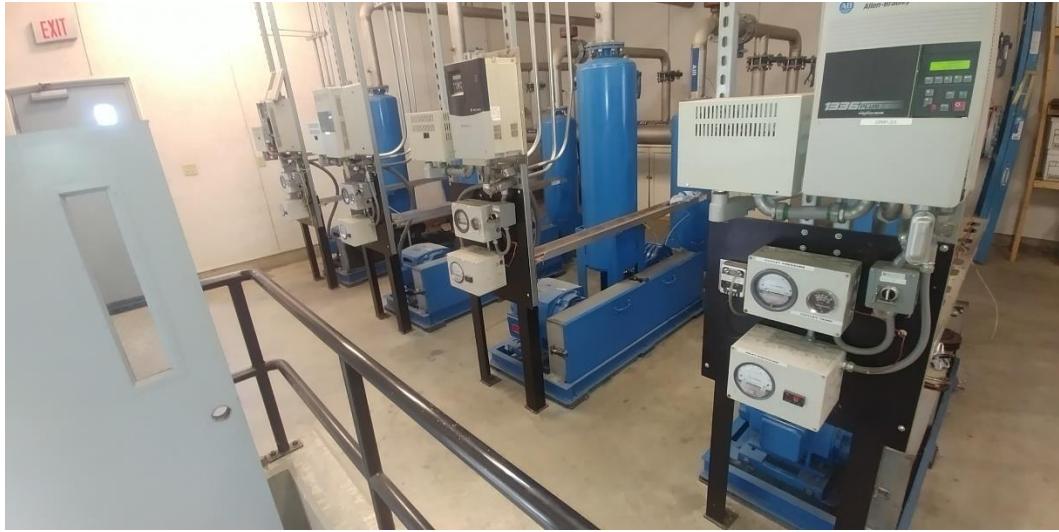
Figure 29: Blowers

The blowers are United Blower, Inc. positive displacement units and appear to be the original to the 2001 upgrade. District staff indicate that the bearings and seals have been replaced several times, and this has been done internally using manufacture's supplied rebuild kits. Currently, blower B-1 and B-4 have been removed and sent to a local machine shop to be checked and rebuilt. The manufacture's sales rep. indicated that the typical life of the blower unit is 10-15 years. The District recently received pricing for a new blower unit which was slightly less than the cost of the recent rebuild.

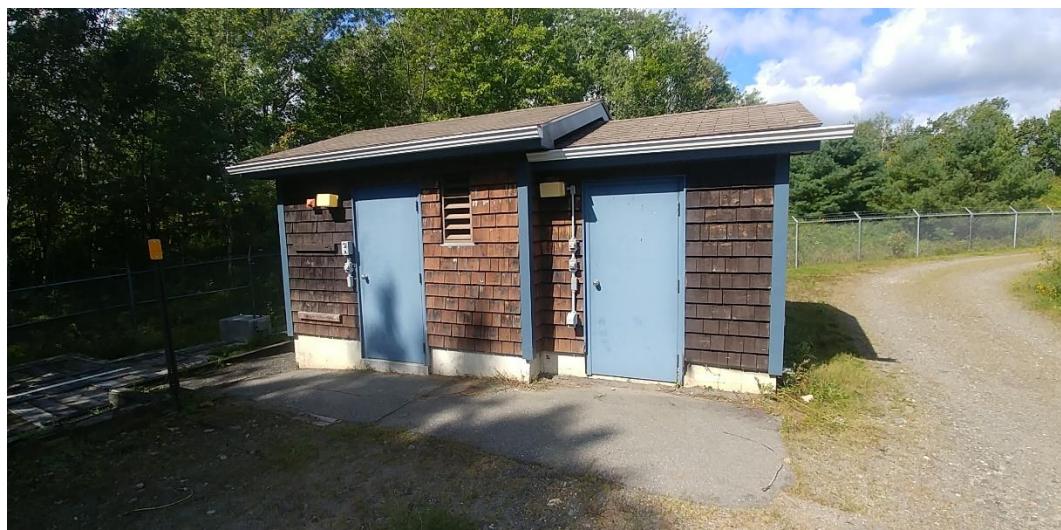
Figure 32: Disinfection Building

The lighting in both sections of the building appears to be in good condition and adequate to light the areas. The lights for both sections are activated from outside of the area and the light switches are adjacent to the entry doors. There is no emergency lighting in either section of the building. We would recommend installing a combination emergency light and exit sign in both rooms of the Disinfection Building. There are two exterior lights that provide lighting at the entry doors.

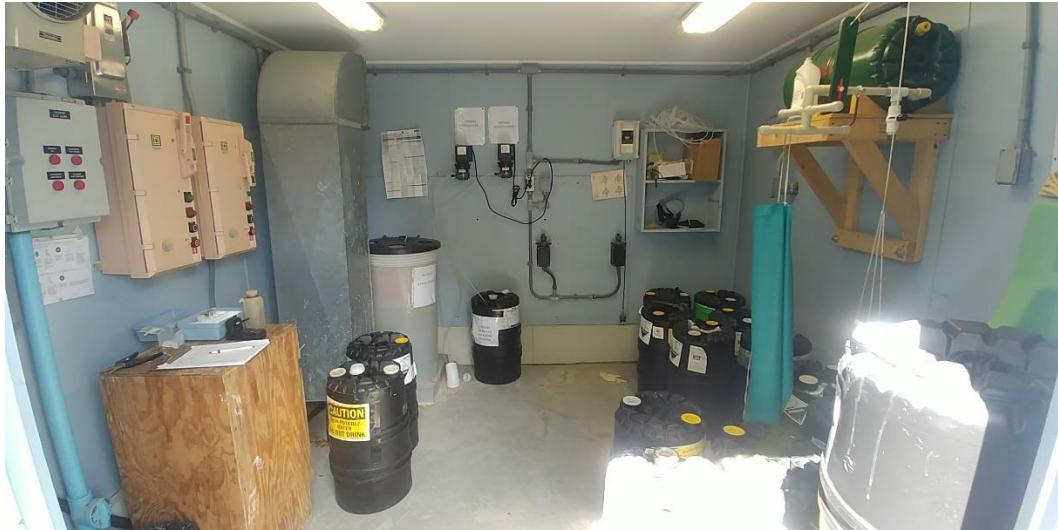
Figure 33: Disinfection Room

There is ventilation provided for the disinfection area and it can be activated from outside of the building. The switch to activate the ventilation is adjacent to the entry door. The switch has become detached from the building and should be remounted. The ventilation fan provides minimal ventilation for the disinfection area of the building. The exhaust fan is concealed in the duct work and was not accessible to inspect and determine the capacity of the fan. A strong chlorine smell was still present after several minutes of fan operation. We would recommend replacing the ventilation system in the chlorination room. The ventilation system can be intermittent and activated when the space is occupied, however further system design would be necessary to determine the specific ventilation fan for this space. The TR-16 guidance indicates that in gas chlorination storage and treatment areas a mechanical ventilation system should provide a minimum of one complete air exchange per minute for the space. The guidance does not reference liquid chlorine however we would recommend that this guidance be used for this space.

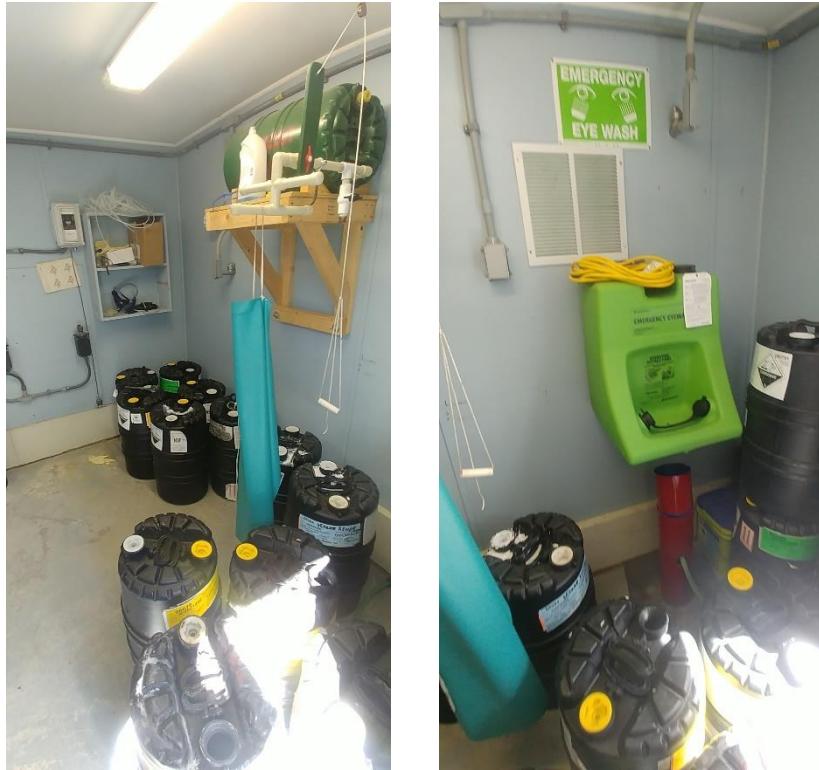
Figure 34 & 35: Disinfection Room Emergency Shower and Eye Wash Station

There is no potable water available at this building. OSHA Requires emergency showers and eye wash stations in areas where caustic or corrosive chemicals are handled and stored. There is a self-contained eye wash station in this room; however, there are numerous chemical barrels that are stored in front of the eyewash station that obstructs access. There is also a home-made emergency shower that does not appear to be adequate to meet OSHA requirements. OHSA requires emergency showers to provide a minimum supply of 20 gallons per minute at a pressure of 30 lbs. per square inch for at least 15 minutes. There are also numerous chemical barrels that are obstructing the access to the emergency shower. The chemical barrels should be removed to provide clear access to the emergency shower and eye wash station and potable water should be provided to this building to support the installation of an emergency shower that meets OSHA requirements.

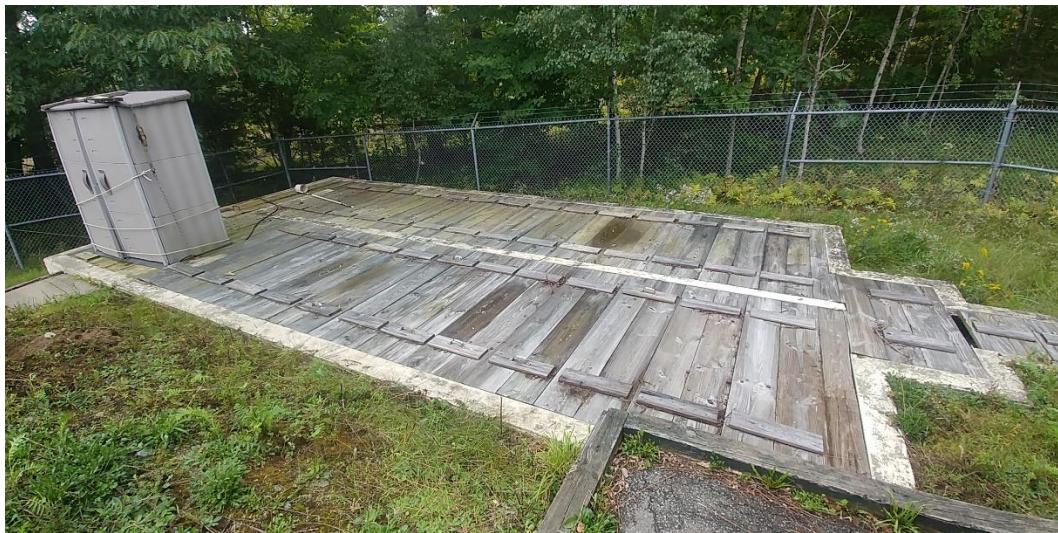
Figure 36: Chlorine Contact Chamber

Overall, the contact chamber is in fair condition. The concrete structure appears to be original to the plant construction and is in good condition. The District has constructed pressure treated wood covers to protect the channels in the contact chamber from debris and UV degradation of the chlorine. These covers appear to be in fair condition. There are numerous trees adjacent to the contact chamber that could be removed to minimize the potential for debris to enter the channels.

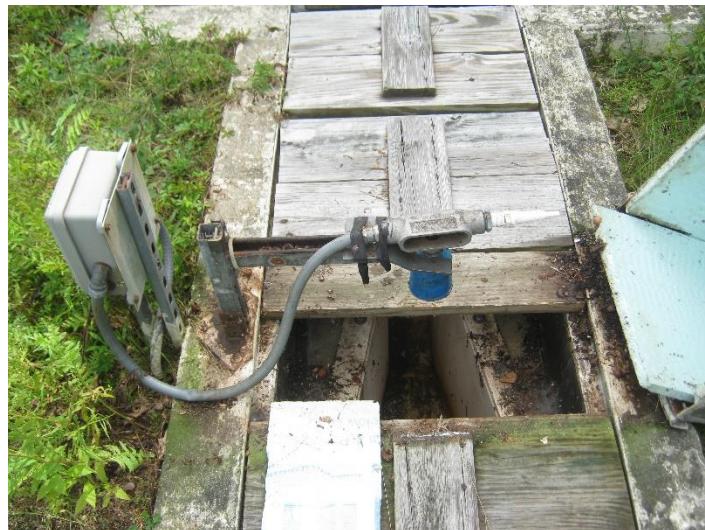
Figure 37: Effluent Flow Meter

The Parshall flume for the effluent flow meter is located at the beginning of the contact chamber. The flume appears to be in good condition. The ultrasonic level sensor that is part of the effluent flowmeter is suspended above the flume. The support for the sensor is currently being held together with electrical tape and should be properly repaired. The Parshall flume should be checked weekly for any build-up of solids and cleaned as necessary. The ultrasonic level sensor should be cleaned annually and if the flow surcharges and covers the sensor.

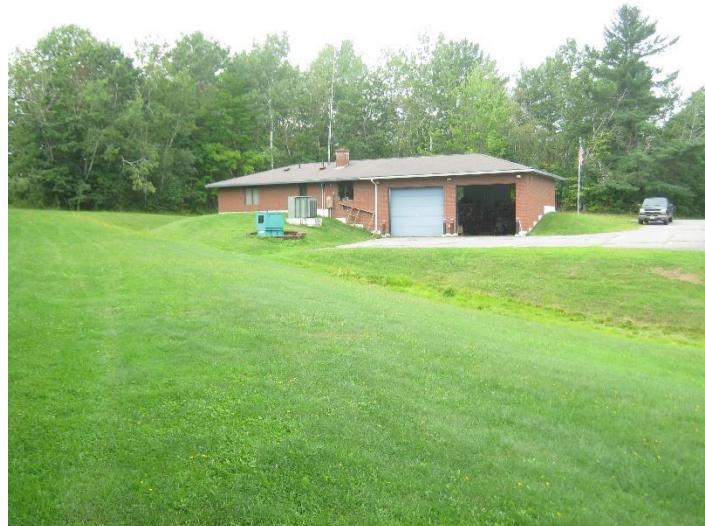
Figure 38: Administration Building

Overall, the Administration Building appears to be in fair condition. The building appears to be original to the construction of the WWTP. The exterior brick appears to be in good condition. The age of the asphalt shingles is not known; however District staff indicate that there are several areas where the shingles have been compromised and caused soft spots in the roof. The District should plan to repair these areas and replace these shingles within the next 5-10-years.
