WASTEWATER COLLECTION AND TREATMENT SYSTEM EVALUATION

FOR VEAZIE SEWER DISTRICT

Veazie, Maine

MARCH 2022
JN: 10243.006

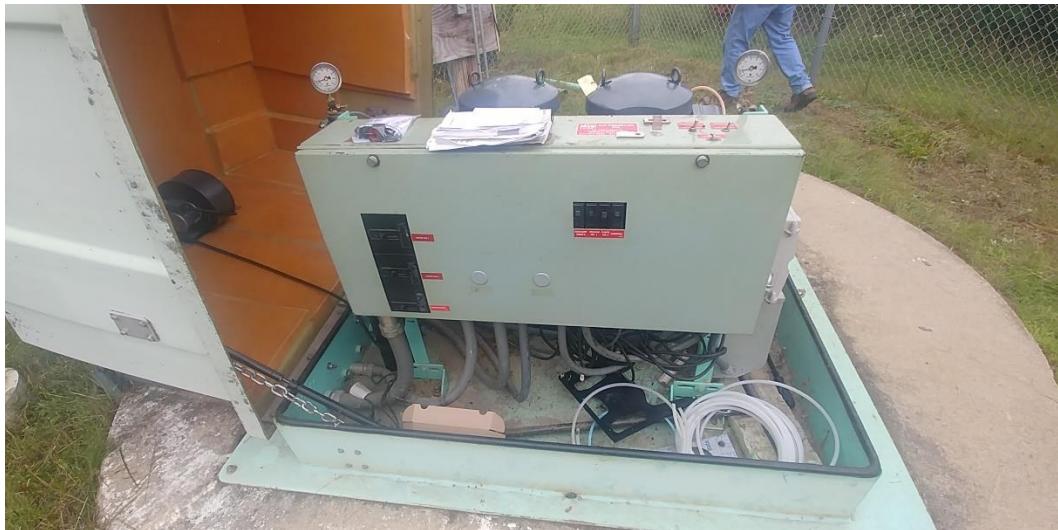
Figure 2: County Road Pump Station Control Panel

able to keep up with influent flow which could lead to Sanitary Sewer Overflow (SSO) events at the station.

District staff indicated that during severe wet weather, a septic hauling company has been used to truck wastewater from this pump station to lower the wet well level and avoid an SSO event. This can be attributed to significant wet weather flows in the collection system due to I&I. However, the reduced capacity of the pump station is the main factor in the pump station's inability to handle wet weather flows.

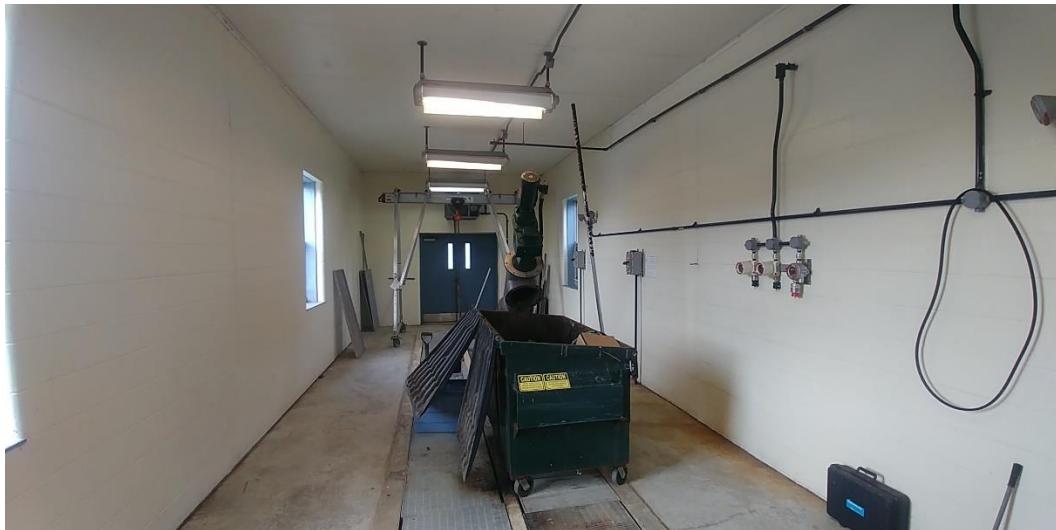
Figure 17: Headworks Building Screening Discharge

the distance that the dumpster is manually rolled or install a new access to the headworks building so the dumpster can be removed without manually rolling to the loading dock.

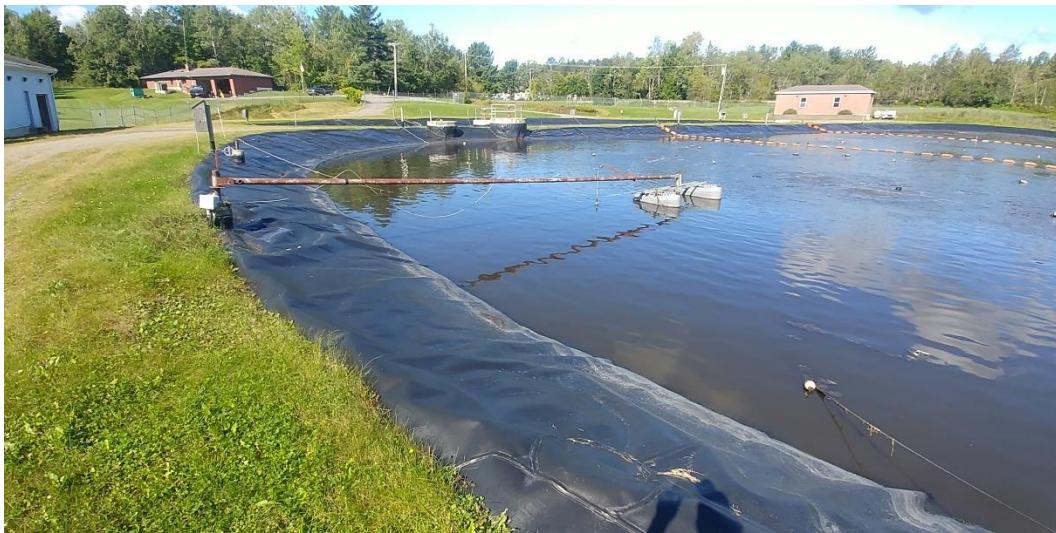
Figure 22: Lagoon #1 Abandoned Equipment

There is a portion of an old floating mechanical surface aerator at the southern end of the lagoon that is no longer in service and should be removed.

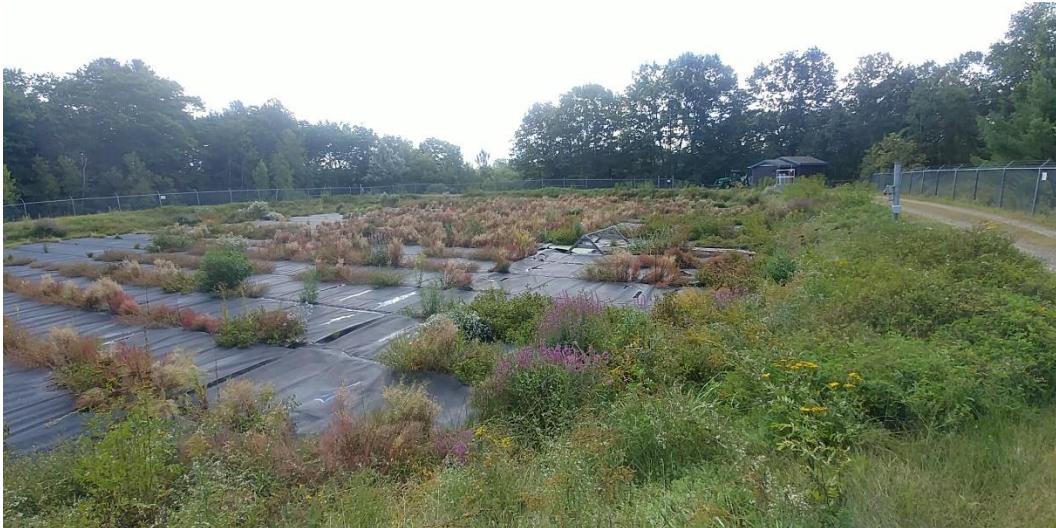
Figure 25: Lagoon #3

manufacturer's information the covers are designed to walk on for inspection, sampling and maintenance purposes.

There are also two openings, approximately 7.2 feet wide by 8 feet long, in the cover system that were used for floating mechanical aerator stations. These aeration stations are no longer used, and the aerators have been removed. The manufacturer indicated that panels could be provided to fill these openings. This would reduce the open area in the cover that supports algae growth.

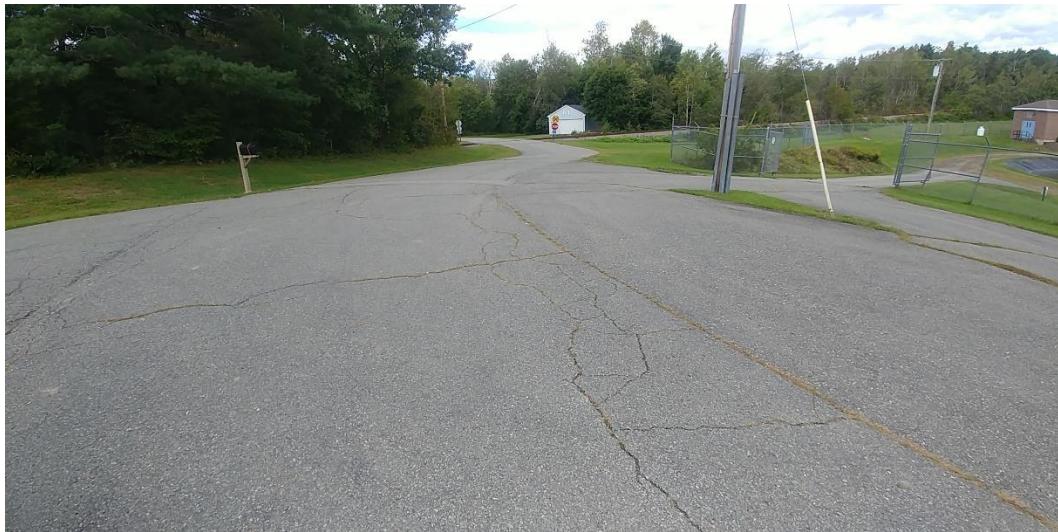
Figure 39: Access Road

expensive project than an overlay. Overlaying the pavement will provide a smooth even surface for walking and plowing and will extend the service life of the existing pavement.
